National Highway Traffic Safety Administration

Case Vehicle (A): 2000 Ford

Veh. (B): 1994 Freightliner

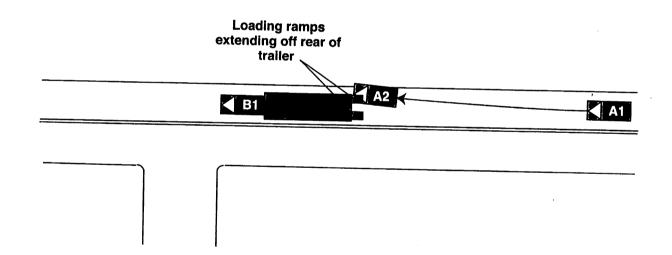
ACCIDENT SCHEMATIC

ACCIDENT DESCRIPTION: Case vehicle (A) was traveling west.	CASE VEHICLE	(A): Z	2000 Ford	F-15	O PU	(
Vehicle (B) was stopped facing west in front of	OTHER VEHICLE	(B): <u>/</u> 9	94 Facial+11	inen ta	acton w/tan	ik
case vehicle (A). Case vehicle (A) failed to stop in time	THIRD VEHICLE	(C):				
And struck the near of vehicle (B) with it left - front.						
·					NORTH

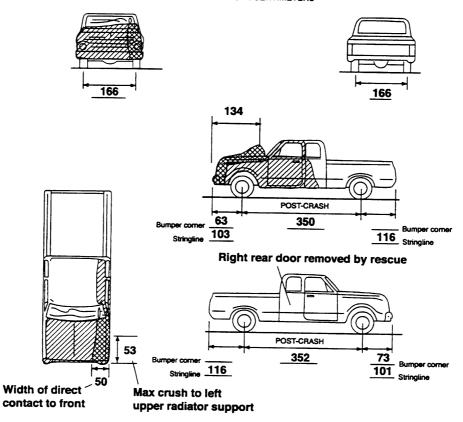
VEHICLE DAMAGE

(Slide 3) Damage to case vehicle (A) was moderate. (Slide 4) Direct damage began at the left-front corner and extended 50 cm to the right, resulting in 30-percent vehicle overlap. Crush profile measurements taken at the level of the upper radiator support revealed that the maximum crush was 53 cm and occurred at the far left of the upper radiator support. (Slide 5) Crush profile measurements for case vehicle (A) at the level of the bumper revealed that the maximum crush at the bumper level was 18 cm to the left-front bumper corner.

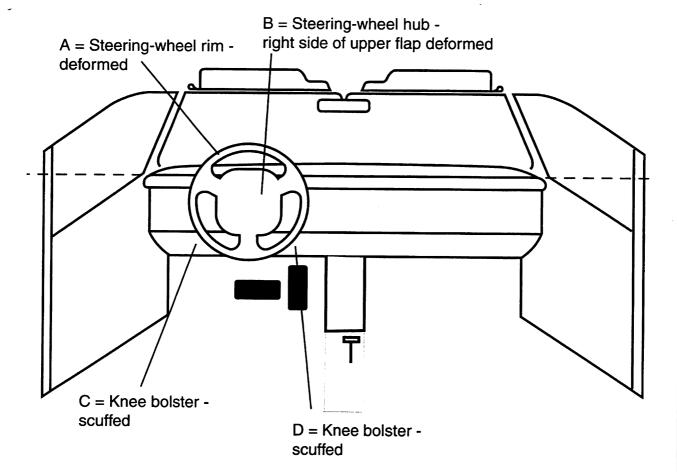
VEHICLE OCCUPANT CONTACT DIAGRAM

Interior	Occupant	Body		Confidence Level of
	Component	No. if	Region		Contact
Contact	Contacted	Known	if Known	Supporting Physical Evidence	Point
A	Steering	DR	Abdomen	deformed	1
	wheel rim				
В	Steering	DR	Lt. arm	deformed	2
	wheel hub				
С	Knee bolster	DR	Lt. knee	scuffed	1
D	Knee bolster	DR	Rt. leg	scuffed	1
E					
F					
G					
Н

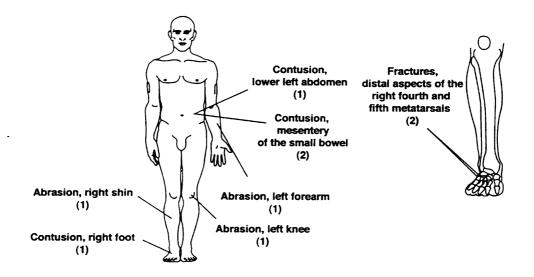
INDICATE LOCATION OF INJURIES.

On impact, the driver moved forward relative to the vehicle interior, into the airbag and knee bolster. The driver sustained a contusion to the mesentery of his small bowel, and a contusion to his lower left abdomen, probably due to contact with the steering wheel and/or the deploying airbag, (slides 55, 56 and 57) as evidenced by the deformed airbag module cover, steering-wheel rim and spokes. He sustained an abrasion to his left forearm, probably due to contact by the deploying airbag. He sustained an abrasion to his left knee, due to contact with the knee bolster. He sustained an abrasion to his right shin, due to contact with the knee bolster, (slide 58) as evidenced by scuff marks on the knee bolster cover to the right of the steering column. He

sustained fractures to the distal aspects of the right fourth and fifth metatarsals, and a contusion to his right foot, due to contact with the brake pedal.
